# Manhole Inspection Summary

Manhole # S63M\_\_010MH

Insp Date: **6/17/08 10:57 AM**

**Location** Address: **5400 Interstate Ave.**

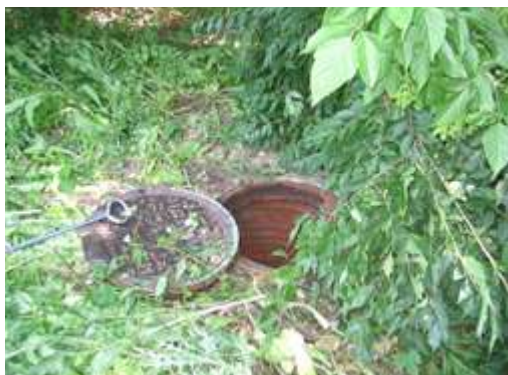
Location View

Comments **LOCATED IN GRAVEYARD.**

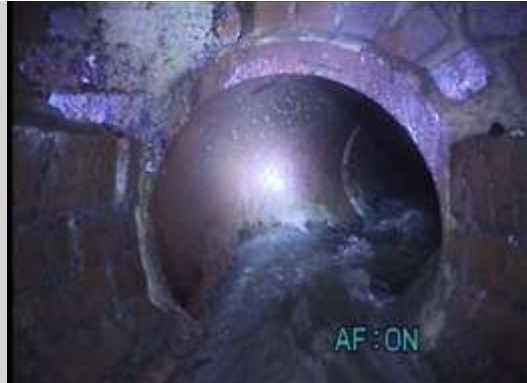
12 O'Clock Outflow

18 in. Circular Gravity Sewer  
Pipe Out @ 12 O'Clock

Pipe Height: **18** (in.) Rod and Bar (Angled)  
Pipe Material: **Clay** ☐ Pipe Lined  
Invert Depth: **14.67** (ft.) Flow Characteristics: **Fast**  
Deposits: ☒ None ☐ Mud ☐ Sludge ☐ Debris ☐ Grease  
Silt Depth: (in.) Deposits Extent:  
Infiltration: **None** Pipe Seal Cond: **Sound**

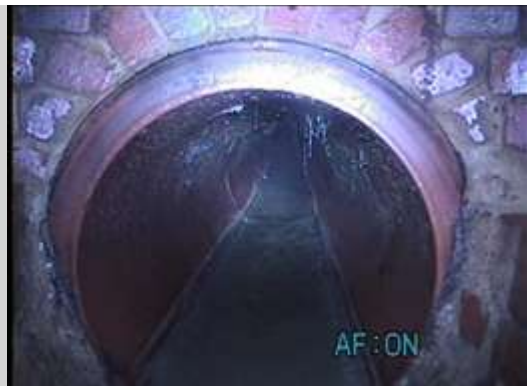
6 O'Clock Inflow

18 in. Circular Gravity Sewer  
Pipe In @ 6 O'Clock

Pipe Height: **18** (in.) Rod and Bar (Angled)  
Pipe Material: **Clay** ☐ Pipe Lined  
Invert Depth: **14.08** (ft.) Flow Characteristics: **Fast**  
Deposits: ☒ None ☐ Mud ☐ Sludge ☐ Debris ☐ Grease  
Silt Depth: (in.) Deposits Extent:  
Infiltration: **None** Pipe Seal Cond: **Sound**
